CIVIL AERONAUTICS BOARD

# AIRCRAFT ACCIDENT REPORT

TRANS WORLD AIRLINES, INC., LOCKHEED CONSTELLATION, MODEL 049,  
N 86511, MIDWAY AIRPORT, CHICAGO, ILLINOIS  
SEPTEMBER 1, 1961

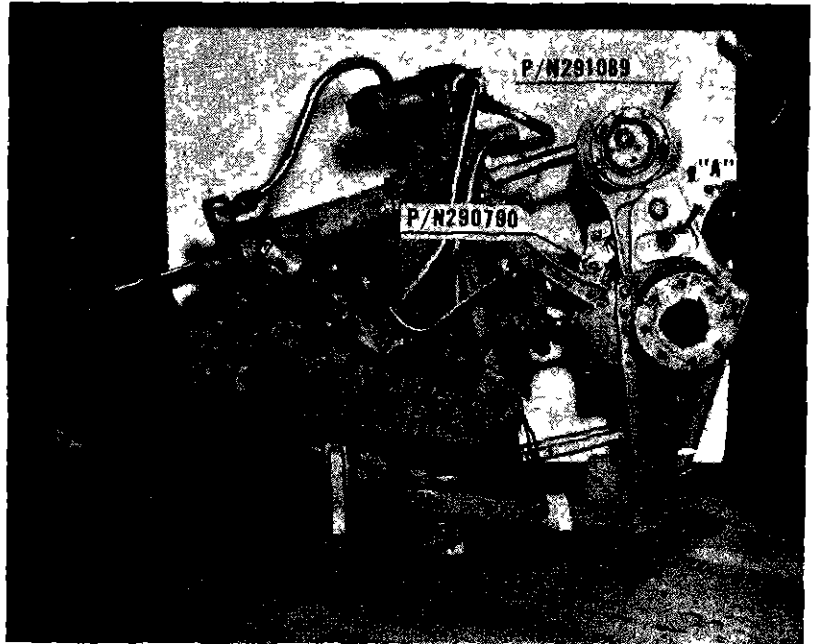
Examination of the parallelogram linkage of the elevator boost located in the extreme aft section of the fuselage revealed a 5/16-inch AN-175-21 nickel steel bolt to be missing. (See Appendix A, Fig. 1.) This parallelogram linkage connects the pilot elevator input to the control valve of the elevator boost system. The bolt was not found in the wreckage despite a thorough search, including sifting of earth in the wreckage area.

The arm assemblies, part No. 291089L, part No. 291089R, and link assembly, part No. 290790 (See Appendix A, Fig. 1), were examined to determine if the bolt was in place at time of impact. This bolt, when in its proper position, passes through the press-fit bushings of P/N 291089 arm assemblies and the P/N 290790 link assembly. The head of the bolt is installed against the outboard face of arm assembly P/N 291089L. On the outboard face of the bushing, which is flush with the face of the forged arm, there were two deposits of old thick grease having the consistency of modeling clay and 0.01 inch or more deep. (See Appendix A, Fig. 2.) The larger of the two grease deposits covered an arc of 120 degrees from the 11:00 to the 3:00 o'clock positions, <sup>2/</sup> and averaged 3/32 inch in width. The inner edge of this deposit was common with the inner circumference of the bushing, whereas the outer edge was, in places, slightly beyond the bushing's outer circumference; however, a slight outline of two sides of the bolt's hex-head was visible around its outer perimeter of the deposit. (See Appendix A, Fig. 2.)

**FIG. 1. Elevator boost package. Bushing where bolt should have been is indicated by arrow "A".**

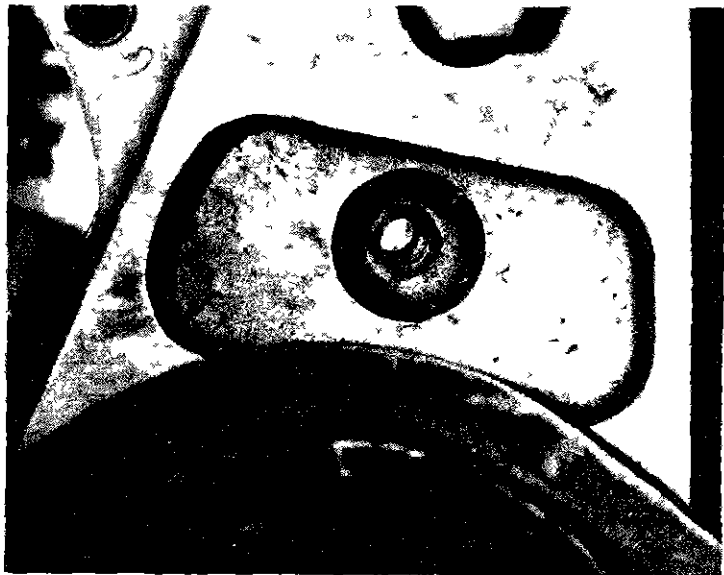
The smaller deposit covered an arc of 60 degrees between the 7:00 and 9:00 o'clock positions and, like the larger deposit, the inner edge was common with the bushing's inner circumference and was about  $3/32$  inch wide.

There were many scuff marks across the faces of both deposits, but neither had received any compressive loads sufficient to flatten their top surfaces. Those portions of the bushing which had no heavy grease buildup showed a film of grease of the same consistency.

**FIG. 2. Close-up view before disassembly of bushing against which head of bolt should have been.**

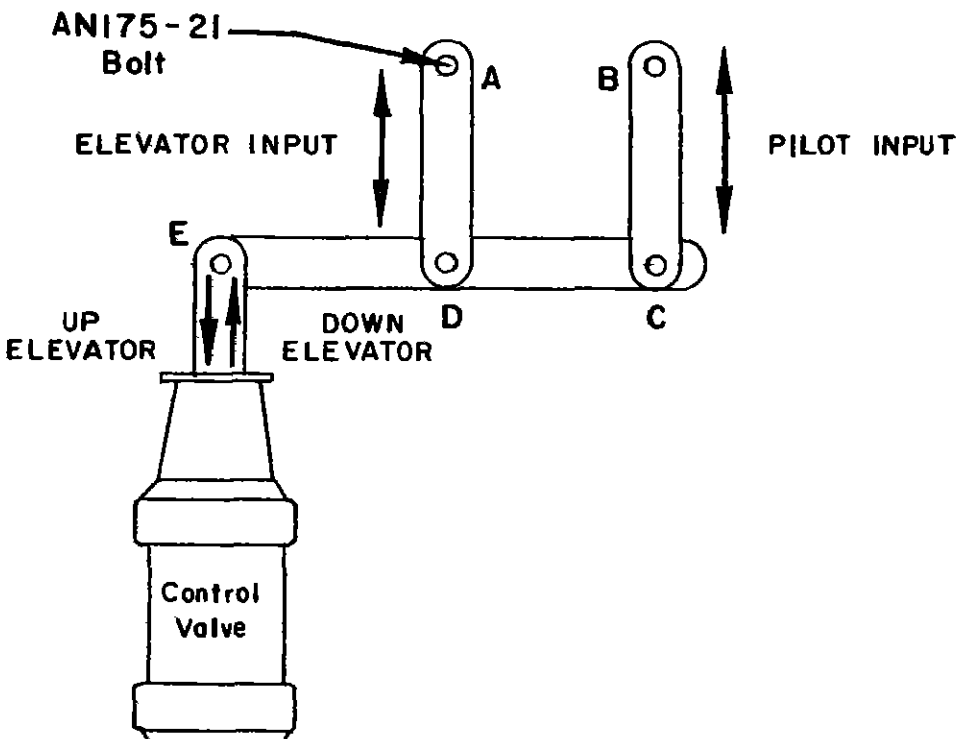
With reference to Appendix A, Fig. 6, it can be seen that pilot input moves link BC up or down which pivots link EDC as a walking beam about point D, causing point E to move down or up. This positions the control valve spool which is connected at point E. Elevator input moves link AD up or down which, in turn, pivots link EDC about point C. This action also positions the control valve spool. It should be noted that pilot and elevator inputs in the same direction are subtractive and inputs in opposite directions are additive to the valve spool.

If the AN-175-21 bolt at point A be removed, no support for the parallelogram is provided by link AD, and link EDC is free to pivot about point C. Since the valve is mounted in a near-vertical position, the weight of links AD and EDC and the weight of the spool are applied in the direction to move the spool toward up-elevator, to be resisted only by the friction in the valve and at points C and E, the total of which is negligible. Any friction above the normal would be overcome by vibration.

Further reference to the sketch shows that there can be no pilot input to the valve to counteract the action since the parallelogram can no longer pivot at point D. Input applied by the pilot is only carried through the mechanical linkage. The mechanical advantage of the system is far too low to be effective against the full pressure in the boost actuator. In a study <sup>5</sup>/of the Constellation boost systems, it was pointed out that the systems will develop approximately 8.5 times more hinge moment with boost on than with boost off. This factor is even greater with the above-described malfunction because the pilot does not have the added mechanical advantage gained by shifting to manual position.

**FIG. 6. Schematic diagram of parallelogram linkage and valve of elevator boost package.**

On November 22, 1961, the Board recommended to the Administrator of the Federal Aviation Agency that the mechanism for shift-to-manual in the Constellation control boost system be modified so that the actions would be sequential rather than simultaneous. Specifically, under the recommended change, the shifting action by the pilot would remain one continuous motion of a handle but would, first, open the bypass valve; second, close the hydraulic shutoff valve and, third, shift the mechanical linkage. With such an arrangement, all hydraulic pressure in the boost package would be relieved prior to the mechanical shift action and would thus allow the complete shift-to-manual without restriction regardless of pilot-applied control forces.
